Control #: D4-300-080

FACILITY STATUS CHANGE FORM

300 Area

329

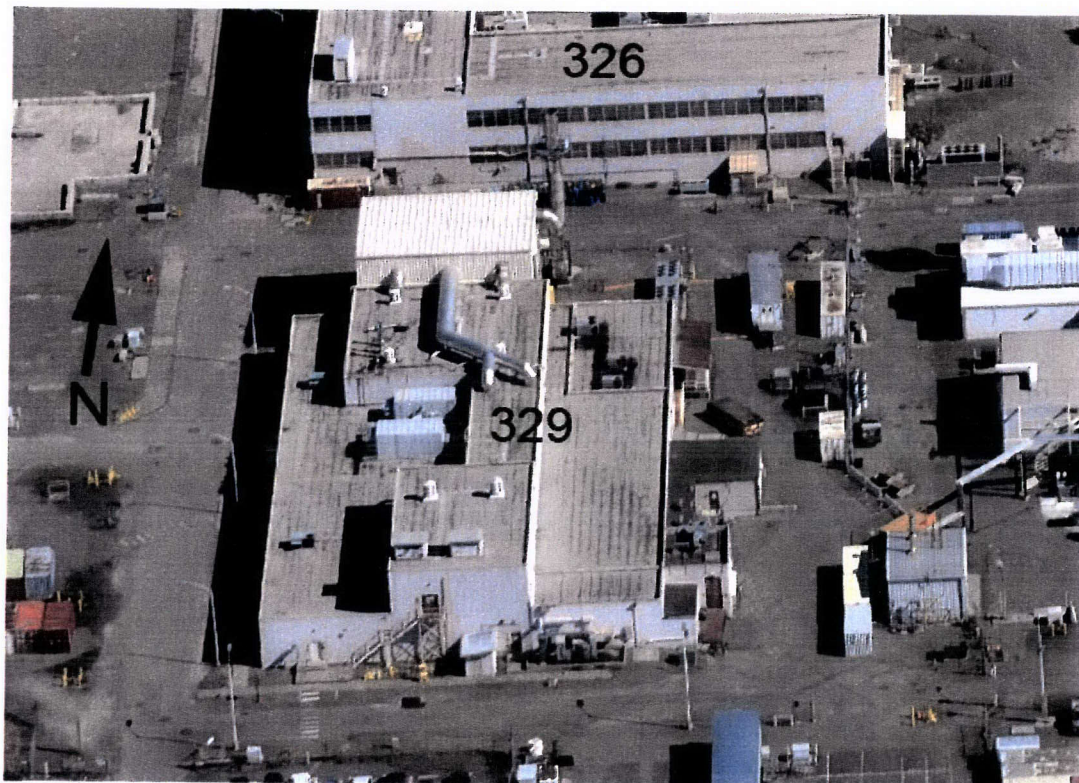
Photograph 1: Looking north at the 329 Chemical Sciences Laboratory in July 2012.

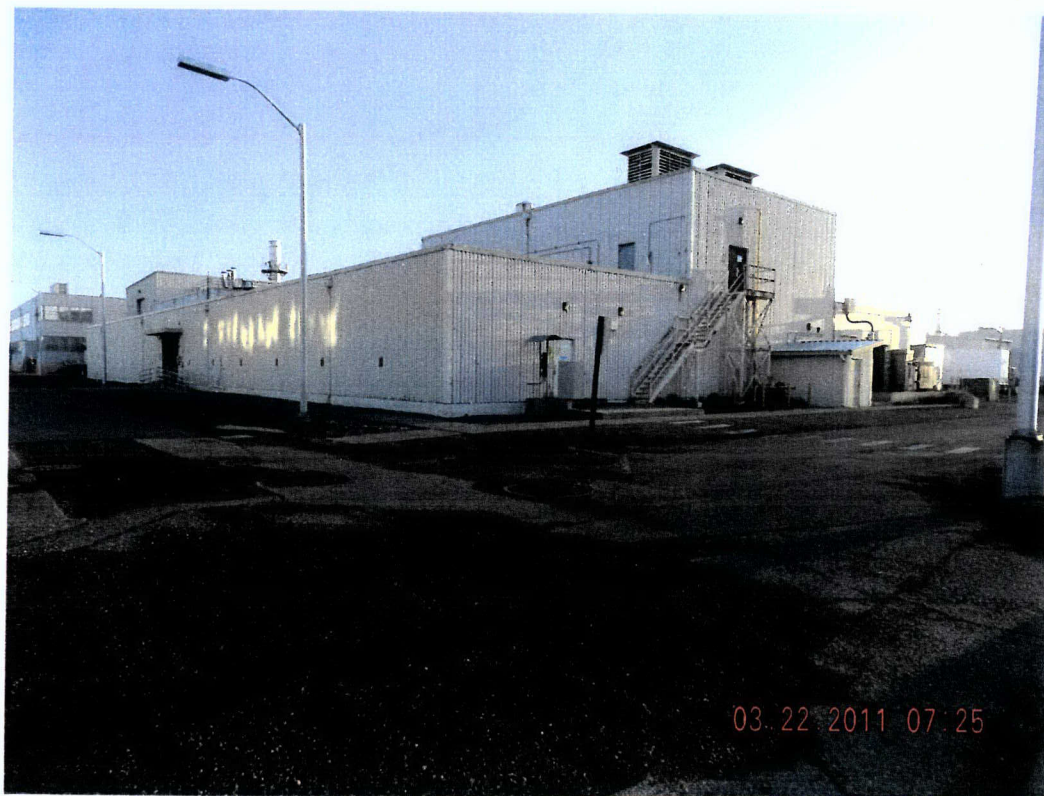
Photograph 2: 329 exterior looking northeast on March 22, 2011.

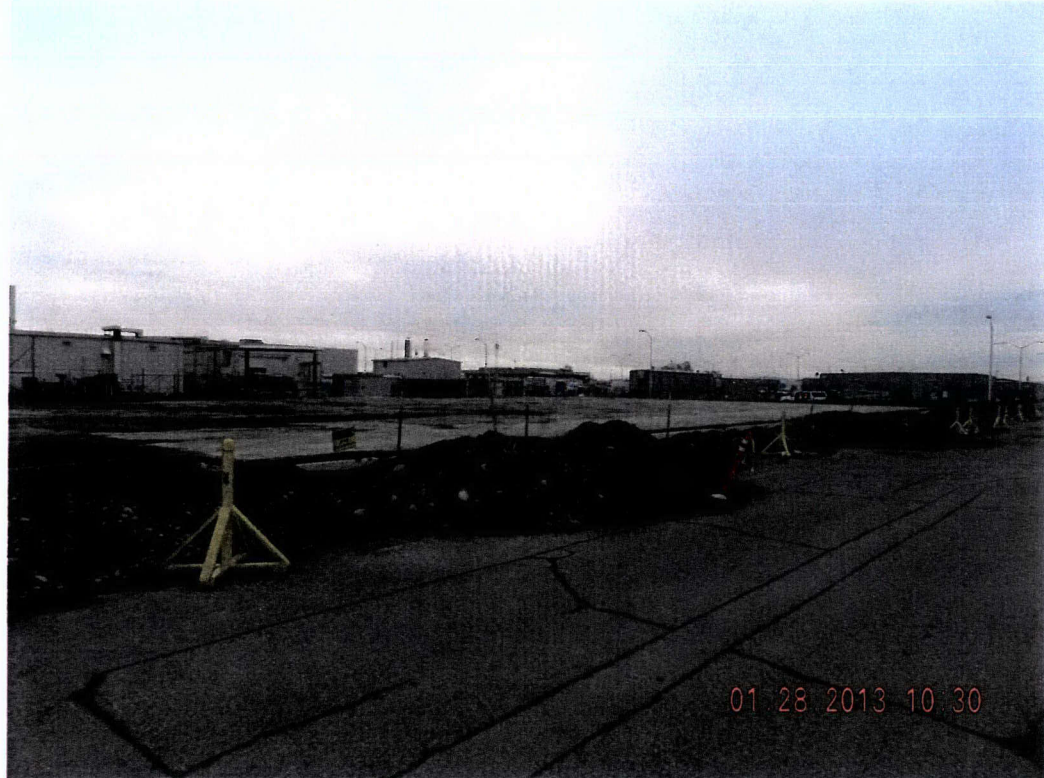
**Photograph 3: 329 slab following above-grade demolition,
looking southeast on January 28, 2013.**

Demolition: Above-grade demolition of the the 329 Building was completed in January 2013. The at-grade slab, partial basement, and neutron monitoring and ion exchange pits remain in place. Removal of these portions of the facility are interfered with by long-term retained utilities that support ongoing operation of the adjacent 325 Building. The building debris from above-grade demolition was removed and disposed of at ERDF. The demolition was performed under Radiological and Industrial Hygiene controls.

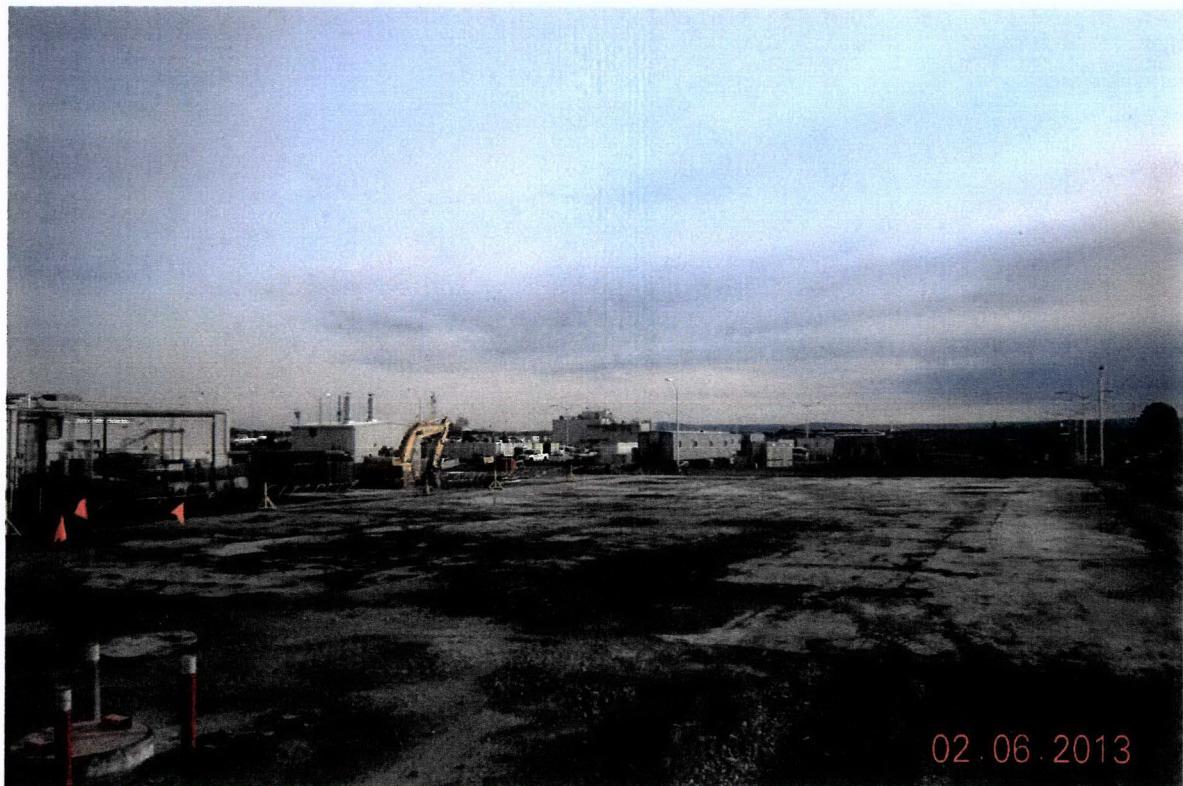
**Photograph 4: 329 slab following final grading and down-posting,
looking southeast on February 6, 2013.**

The 329 at-grade slab and grout-filled basement and pits remain. IH and radiological down-posting of the area is complete. A final GPERs survey of the slab was performed, no postings remain.
